MARINE INVESTIGATION REPORT
M01W0006

FATAL ACCIDENT

CONTAINER SHIP *ALLIGATOR VICTORY*
DELTAPORT, VANCOUVER, BRITISH COLUMBIA
09 JANUARY 2001

Report Number M01W0006

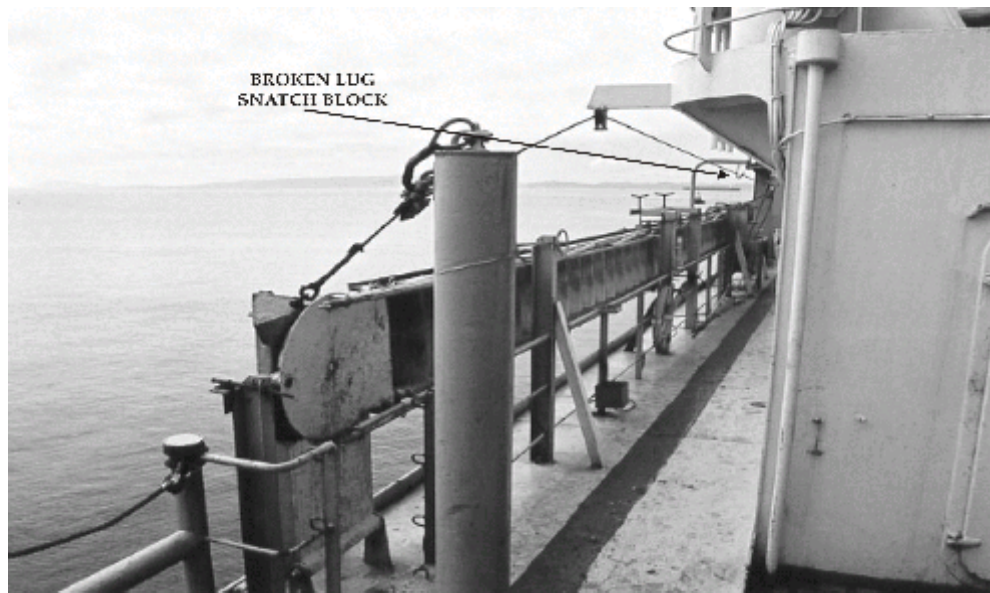
Figure 2. Location of broken pad eye and snatch block.

One of the crew members operated the controls of the electric winch while another stood under the snatch block by the railings, watching the ascent of the ladder and guiding the operator. Just before the gangway reached its final stowage position, the pad eye securing the snatch block to the side post suddenly parted. The abrupt releasing of the snatch block, when there was still tension on the falls, caused it to swing violently outward and strike the seaman standing in its path. Though he was wearing a hard hat, the snatch block hit him on the forehead and face; he later succumbed to his injuries. Ship damage was limited to one broken pad eye.

- b) All pad eyes in way of the accommodation ladders were renewed, and guide blocks and shackles were serviced/replaced as required.
 - c) Both accommodation ladders were operationally tested, to the satisfaction of the attending Class NK surveyor.

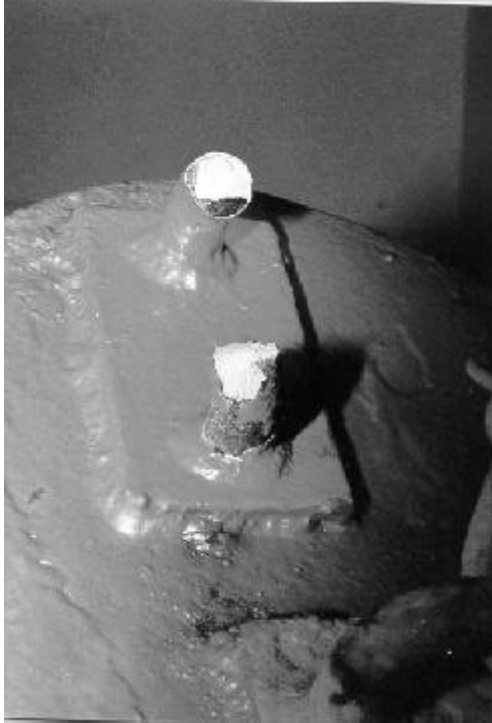
Inspection of the broken pad eye revealed two pre-existing cracks that had formed some time ago. The cracks were on the inside curvature of the pad eye and had escaped detection during preventive maintenance. The pad eye was subjected to repeated, nonuniform loading and unloading as the gangway was lowered and raised. Initially, the cracks were two points of stress concentration that slowly became enlarged, one of which had extended to almost 25% of the cross-sectional area of the pad eye. The failure occurred as a result of tensile overload

when the remaining intact area was insufficient to carry the load imposed on it.

Figure 3. View of broken pad eye. Dark areas in the cross section show the pre-cracks.

1. The pad eye securing the snatch block—through which the falls were reeved—parted and released the snatch block. The snatch block then violently hit in the forehead a crew member, who succumbed to his injuries.
2. The pad eye broke in two; the failure was caused by shear from tensile overload.
3. The pad eye was found to be cracked in two places. (These cracks were previously formed and had slowly become enlarged.) One of these cracks extended to about 25% of the cross-sectional area of the pad eye.
4. The vessel's planned maintenance had failed to identify the existence of these two cracks.

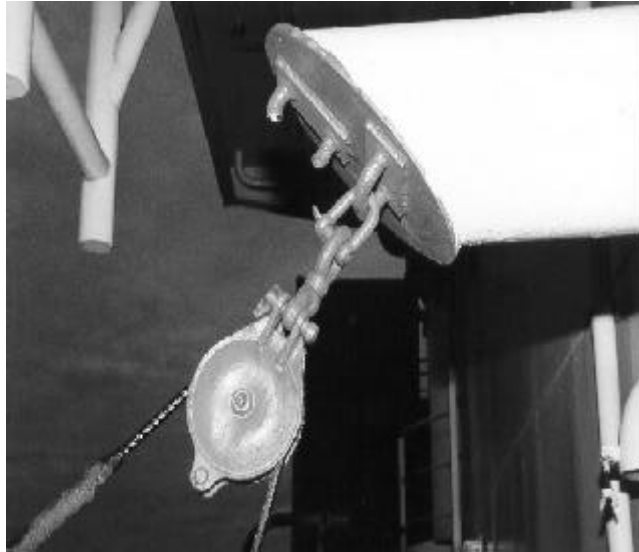
Figure 4. View of broken pad eye.
